Weatherby Lake 5 Year Sewer Plan #1 Rev 2 July 2010

Introduction

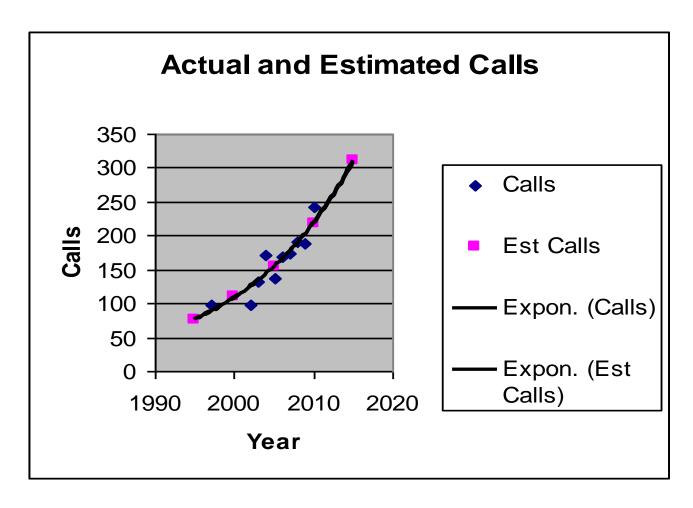
Each parameter was arbitrarily chosen (except the 2) and the final parameters were c=5, y=100/100 for the model verification and y=165/100 for the cost optimization and x= (pump group age)/10. The following graph illustrates a very good match to the data.

As can be seen the two lines correspond almost exactly

Where "F" is the number of pump trouble calls; "c" is a coefficient selected; "y" is the number of pumps in each group divided by 100; "2" means there is a doubling of trouble calls for every "x" period of time; and x is the age in years of the group of pumps divided by the years to double the number of calls.

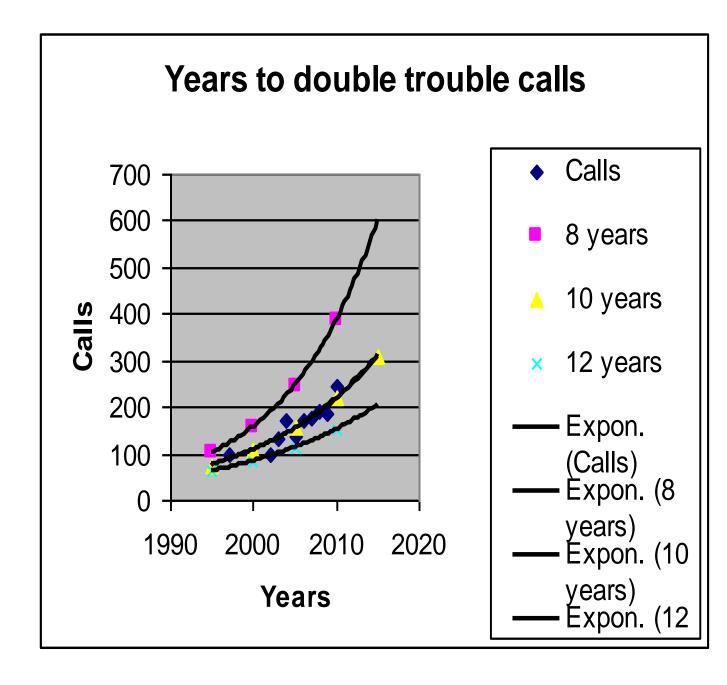
Next the "x" parameter was varied from 10 years to double the number of calls to 8 years and 12 years. As can be seen from the below chart that the two year difference from 10 years results in much less satisfactory match with the data of Attachment 4

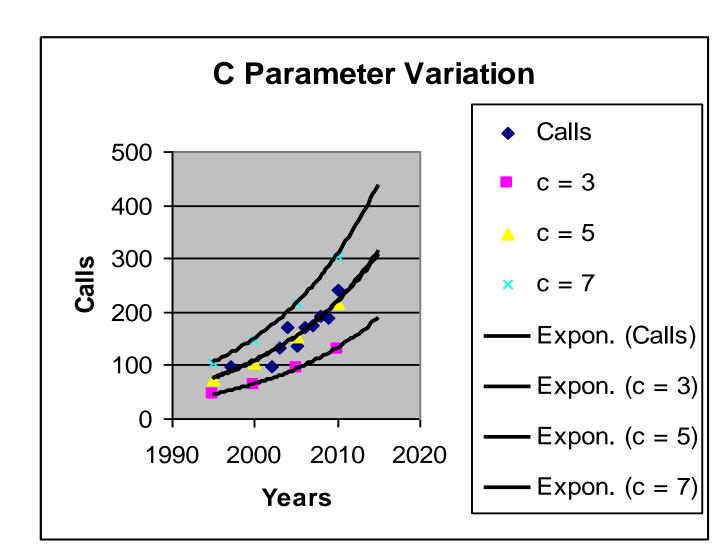
Next the "c" parameter was varied from 5 to 3 and 7. As can be seen from the below chart that the difference from the coefficient of 5 results in less satisfactory match with the data of Attachment 4.

The "y" parameter was set to one by using pump groups in increments of 100 and therefore does not affect the validation process. This concludes the model verification and the model is judged to be acceptable to determine cost information.
